EAST ELEVATION

CHISANA

HISTORIC STRUCTURE REPORT

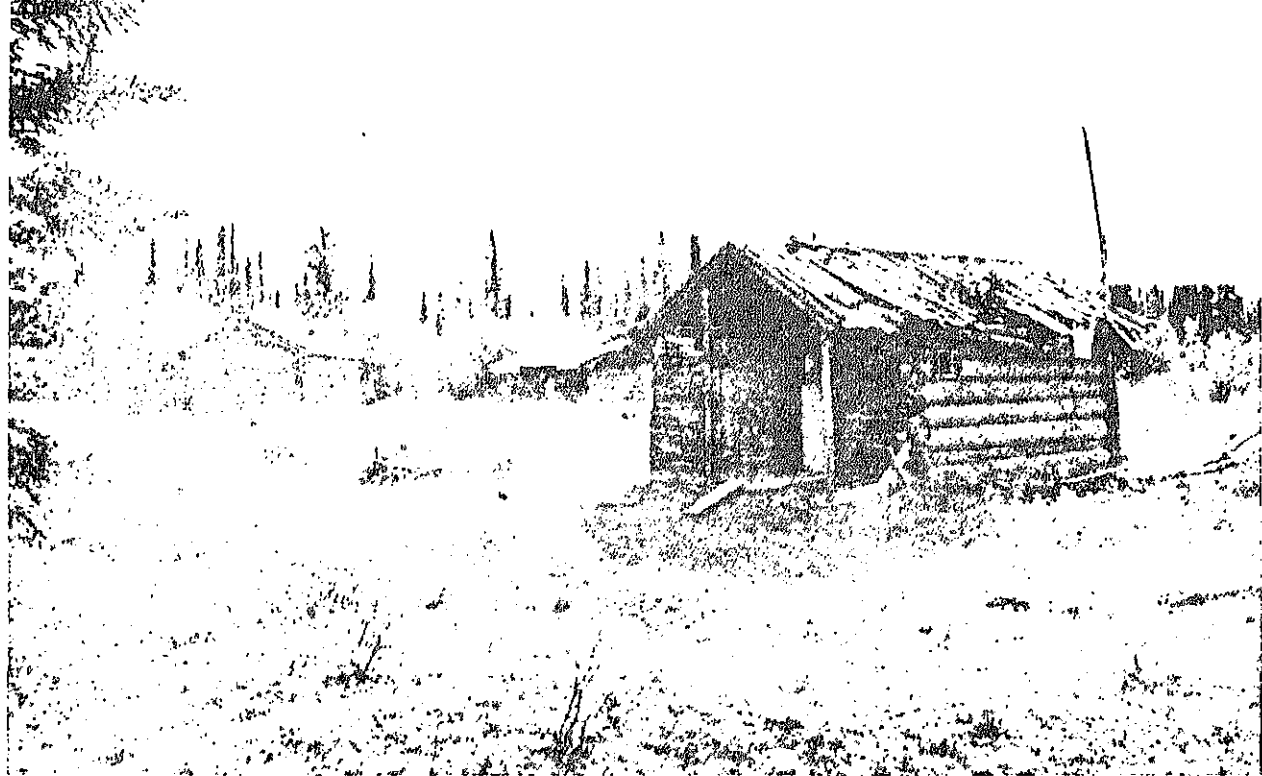
Photograph 1
Women's Jail, Chisana
Northeast Oblique.

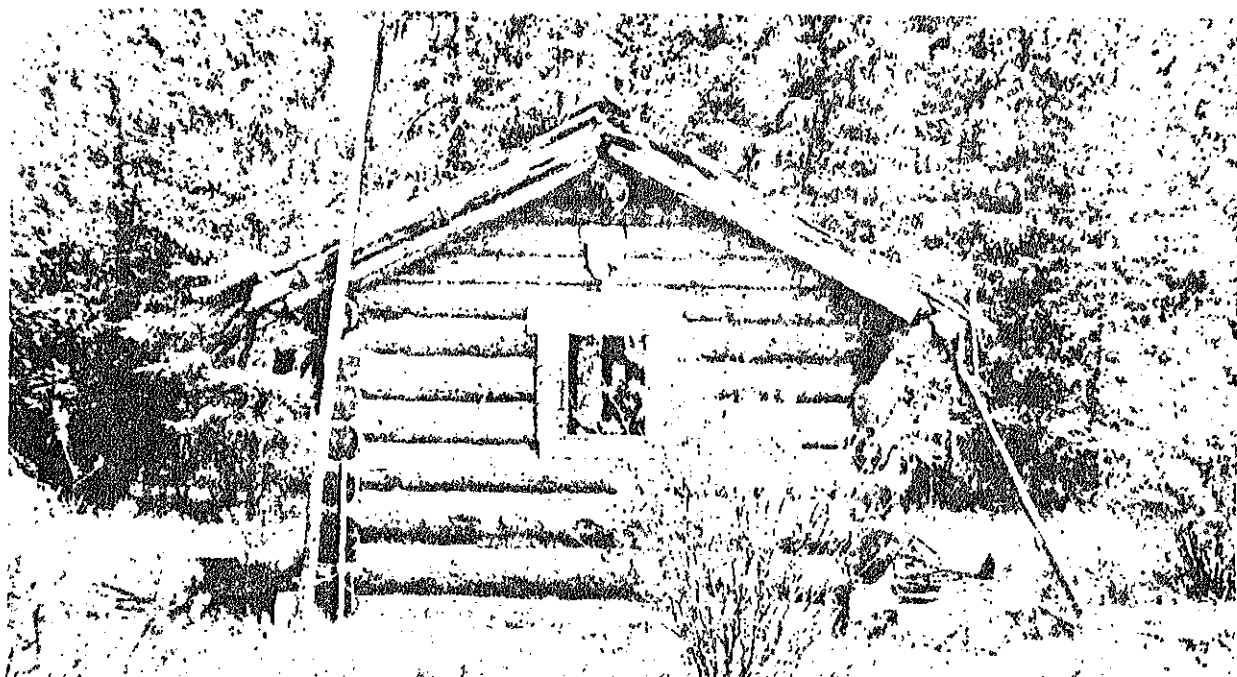
Photograph 4
Women's Jail, Chisana
West Elevation.

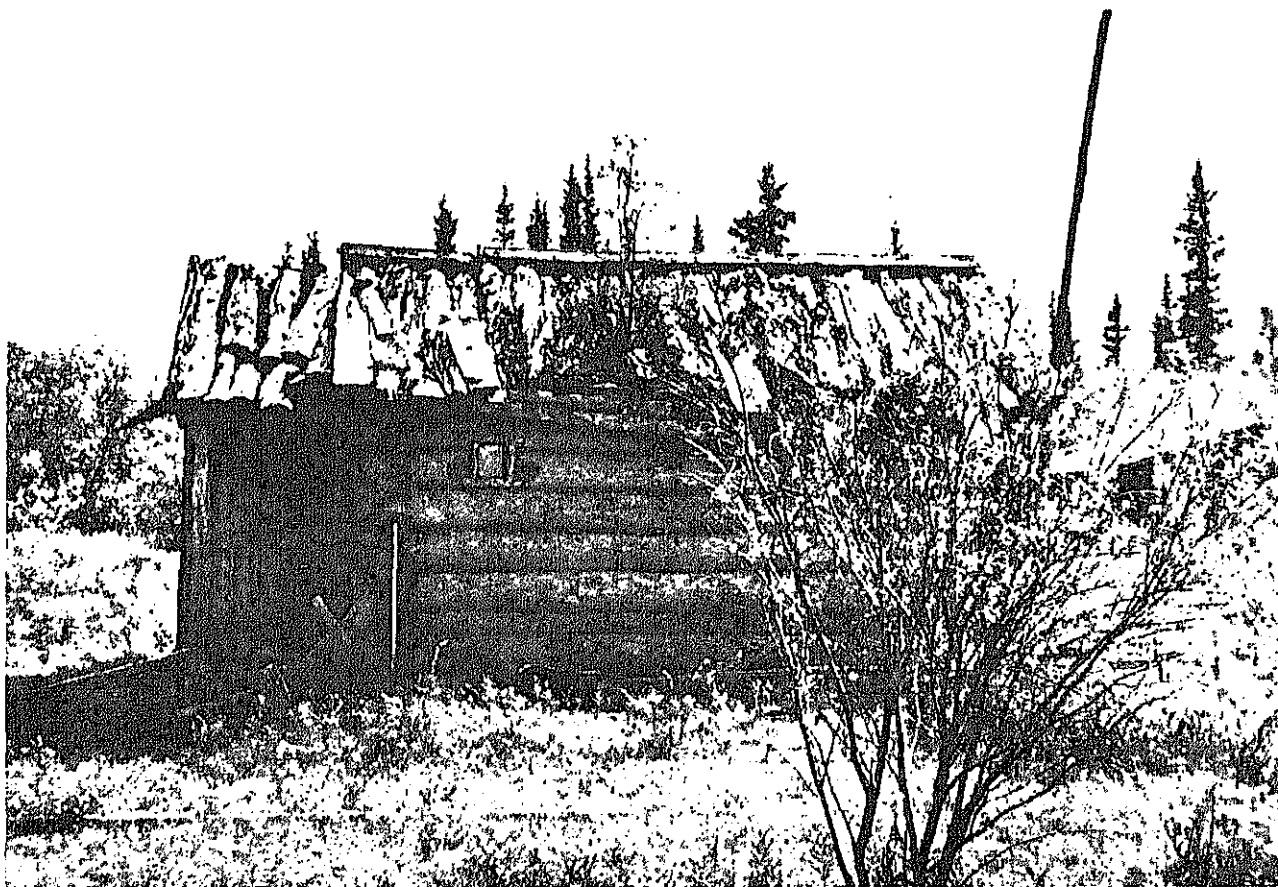
Photograph 5
Women's Jail, Chisana
North Elevation.

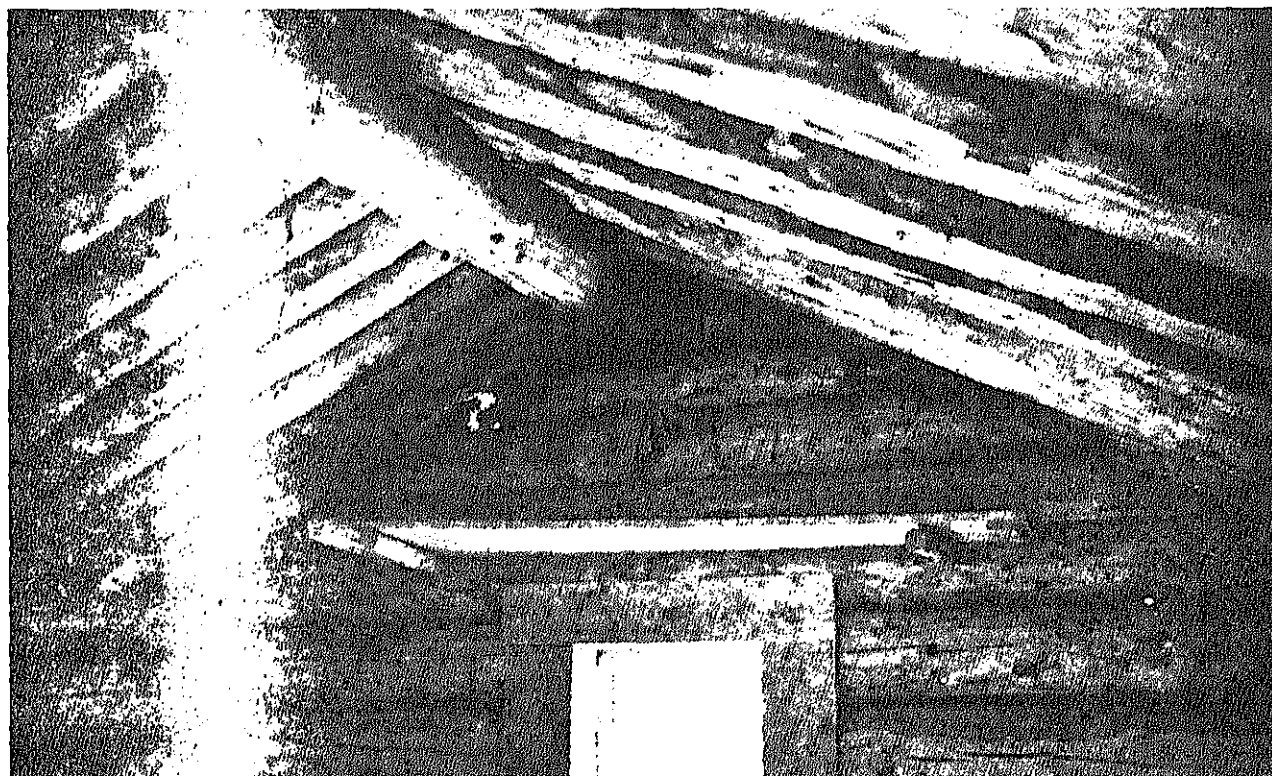
Photograph 8
Women's Jail, Chisana
Interior; West wall, shelf & window.

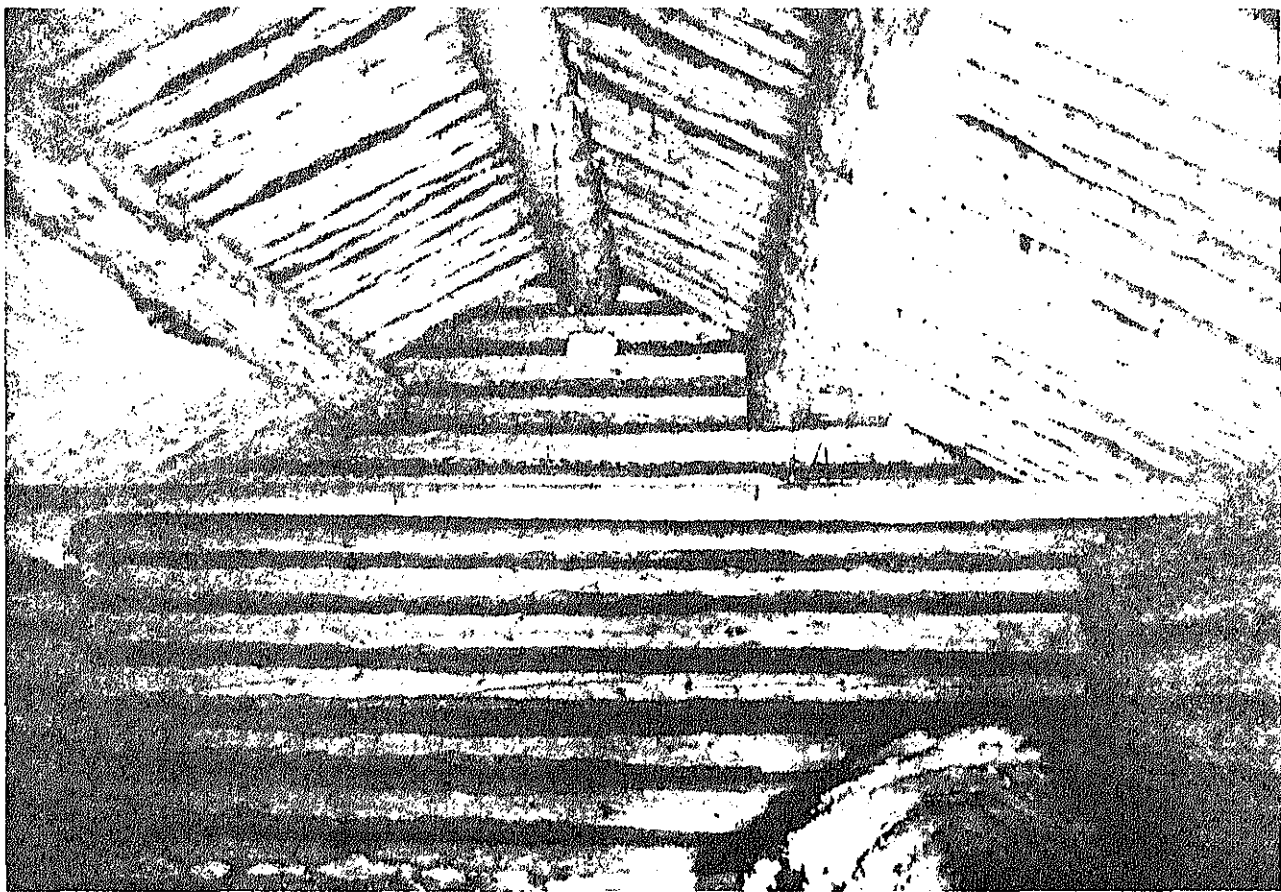
Photograph 21
U.S. Commissioner's Court, Chisana
Ceiling & North wall, showing split-
log ceiling members and peeled
purlines & ridge beam.
